Performance of Earthquake Damage Beams Repaired via Epoxy Injection

Mehdi Sarrafzadeh, Ken Elwood - University of Auckland

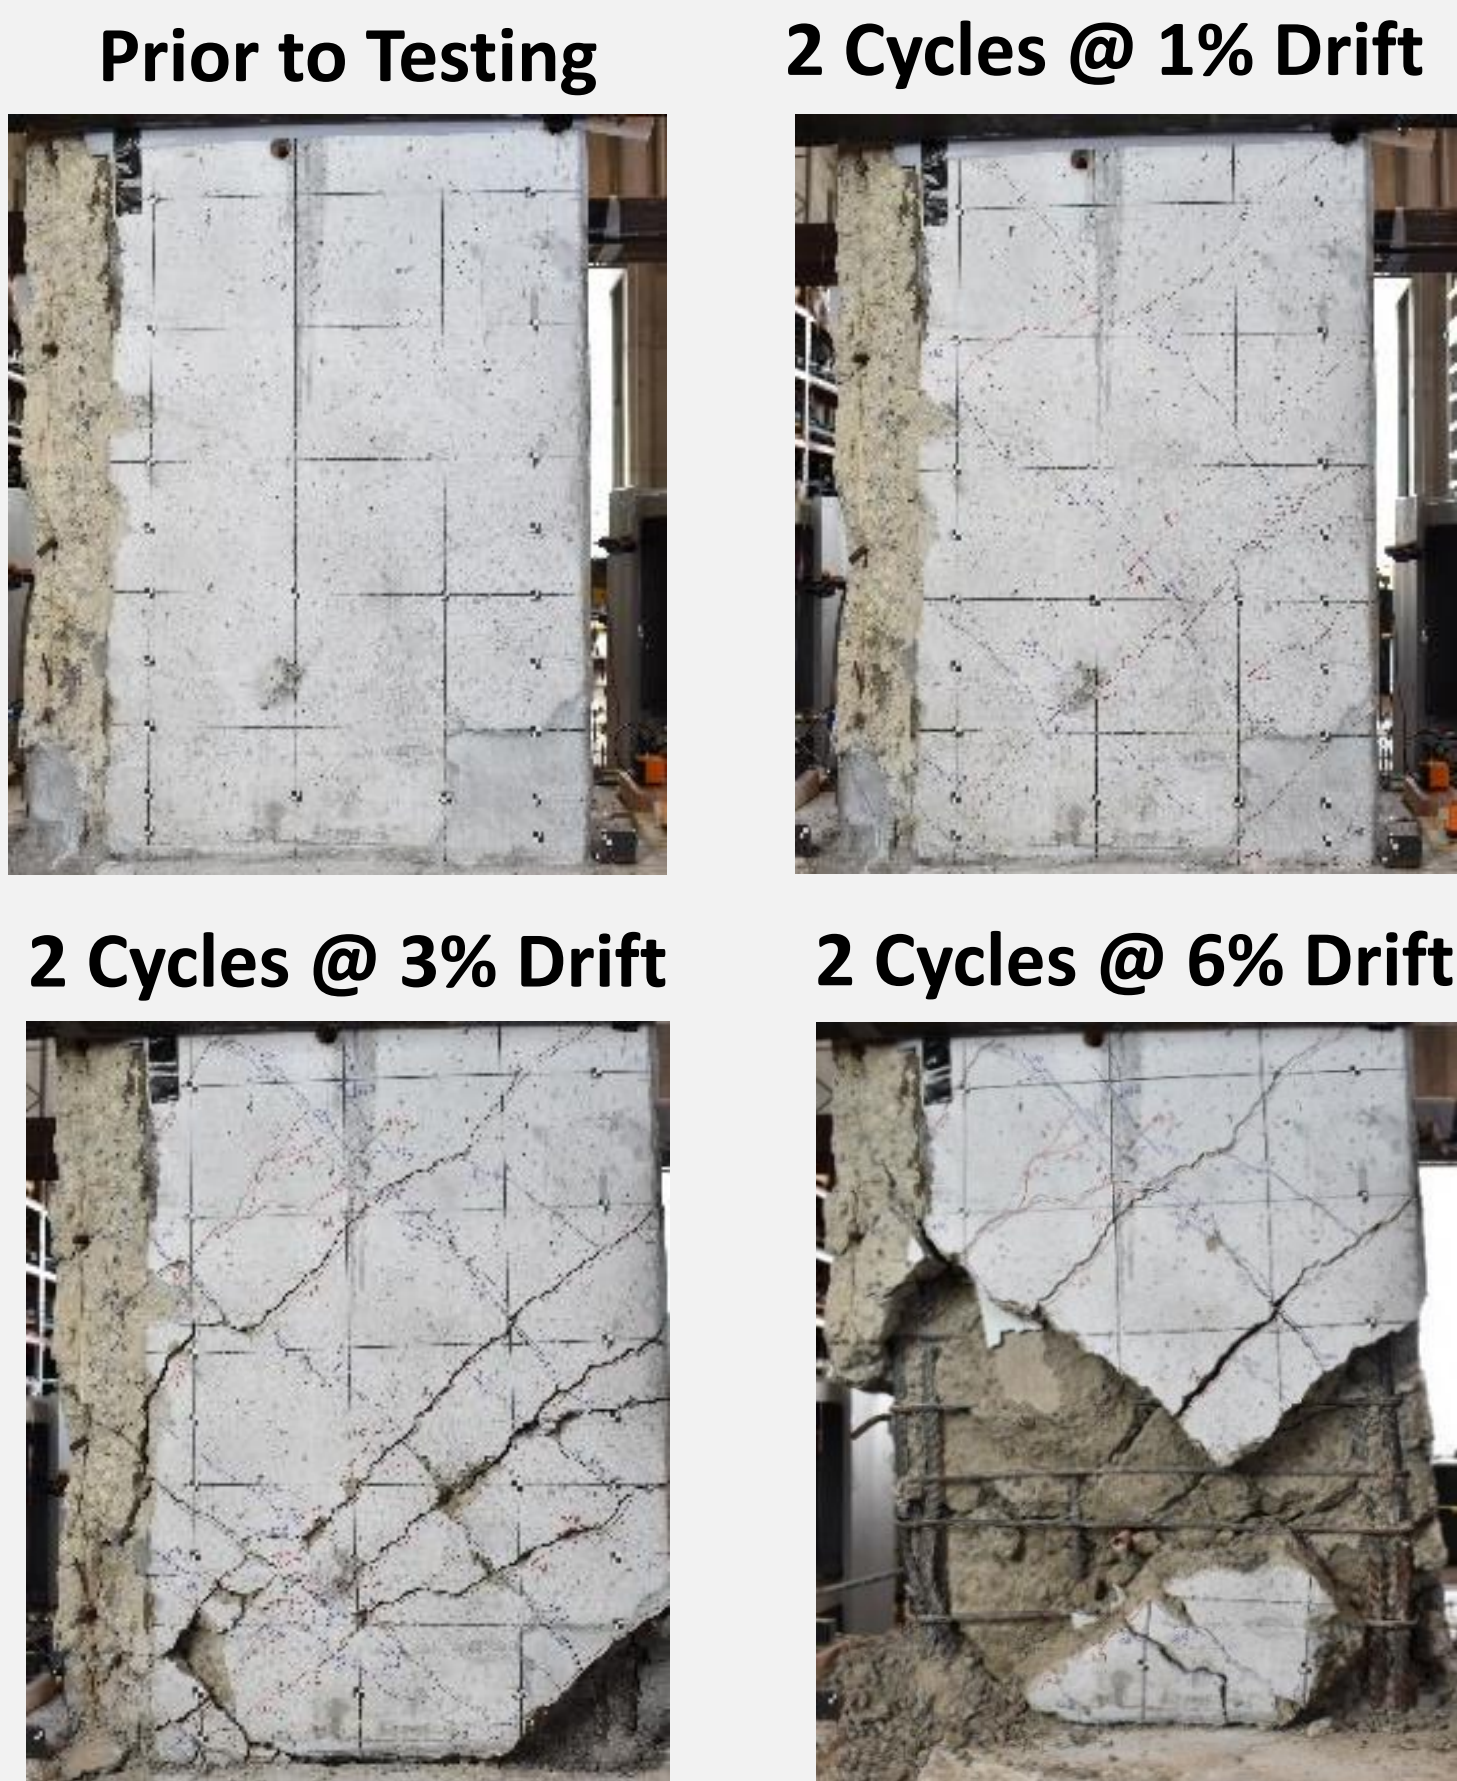
Figure 3: Damage Progression for Specimen E-R, Indicative of all specimens.

- Specimens saw significant spalling at 4% drift with signs of core crushing. Following cycles to 6% drift buckling of longitudinal reinforcement was also evident. All specimens saw a 20% drop in strength on the second cycle to -6% drift coinciding with the unhooking of the stirrups. No bar fracture was observed (See Figure 2 for comparison of hysteresis for specimen E-U and E-R).

- Specimens showed consistent damage progression, with significant diagonal shear cracking in the plastic hinge region, similar to the in-situ earthquake damage (Fig. 3).

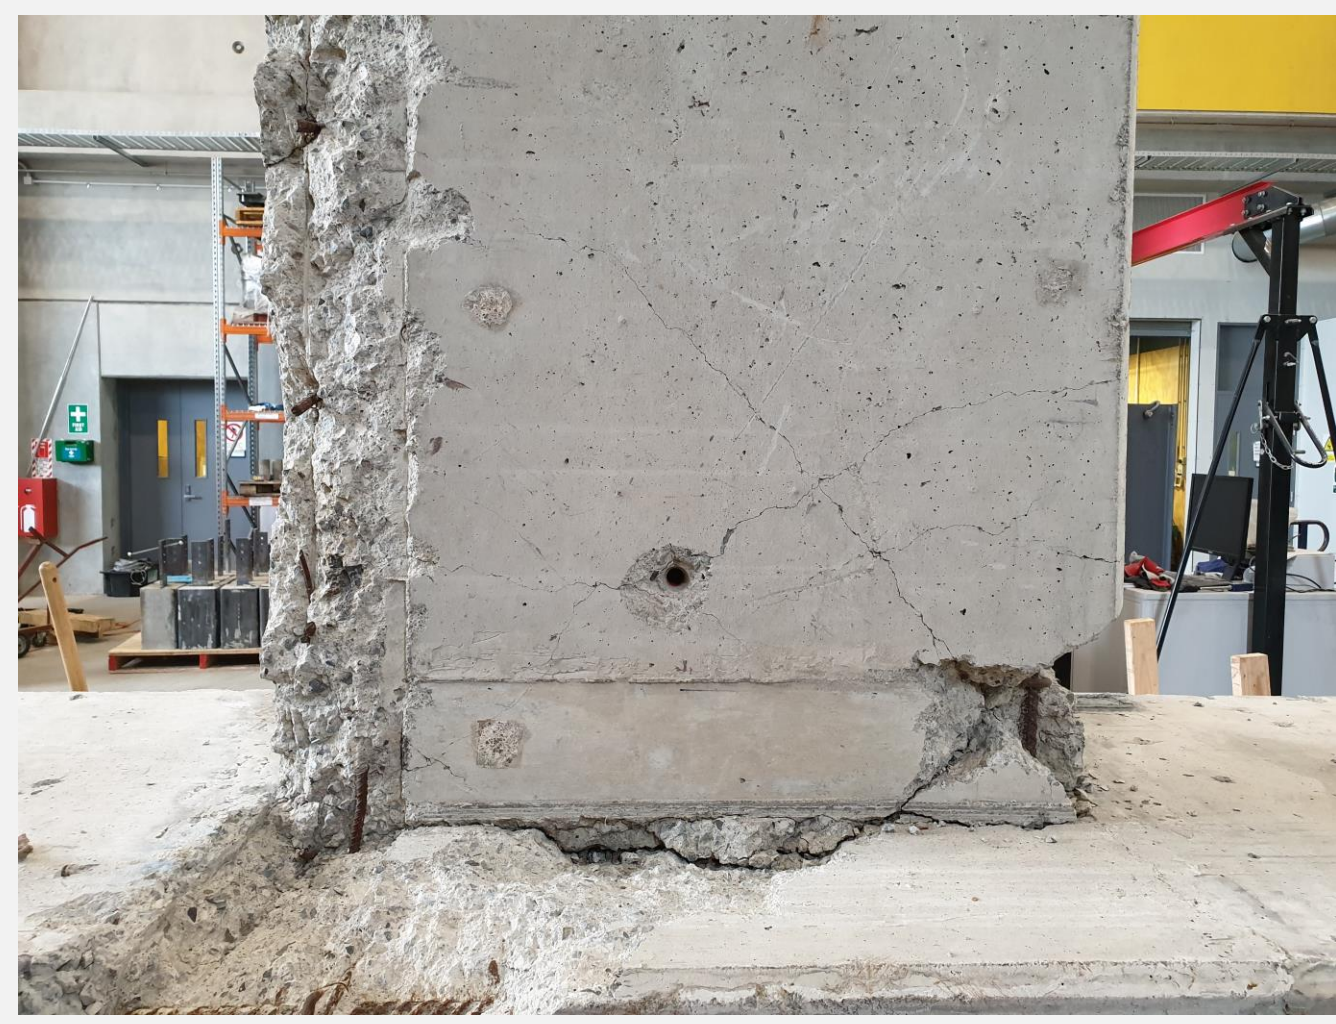
Post EQ Damage

Two internal and two external beam-column (b/c) joints were removed from the fourth floor above ground of a RC perimeter frame structure. The building was designed to a ductility of 6 and was expected to have gone through inelastic behaviour during the Kaikoura earthquake. All steel reinforcement was grade 300E with a specified concrete strength of 25MPa. The longitudinal reinforcement ratio, ρ_l , of all specimens was 0.6%. The beams spanned ~4.8m between the column faces in the frame and satisfy all detailing requirements of NZS 3101:2006-A3. External b/c joints had cracking in the plastic hinge region up to 5mm wide with some cover spalling, while internal joints had hairline cracking with only one major crack adjacent to the joint region up to 2mm wide.

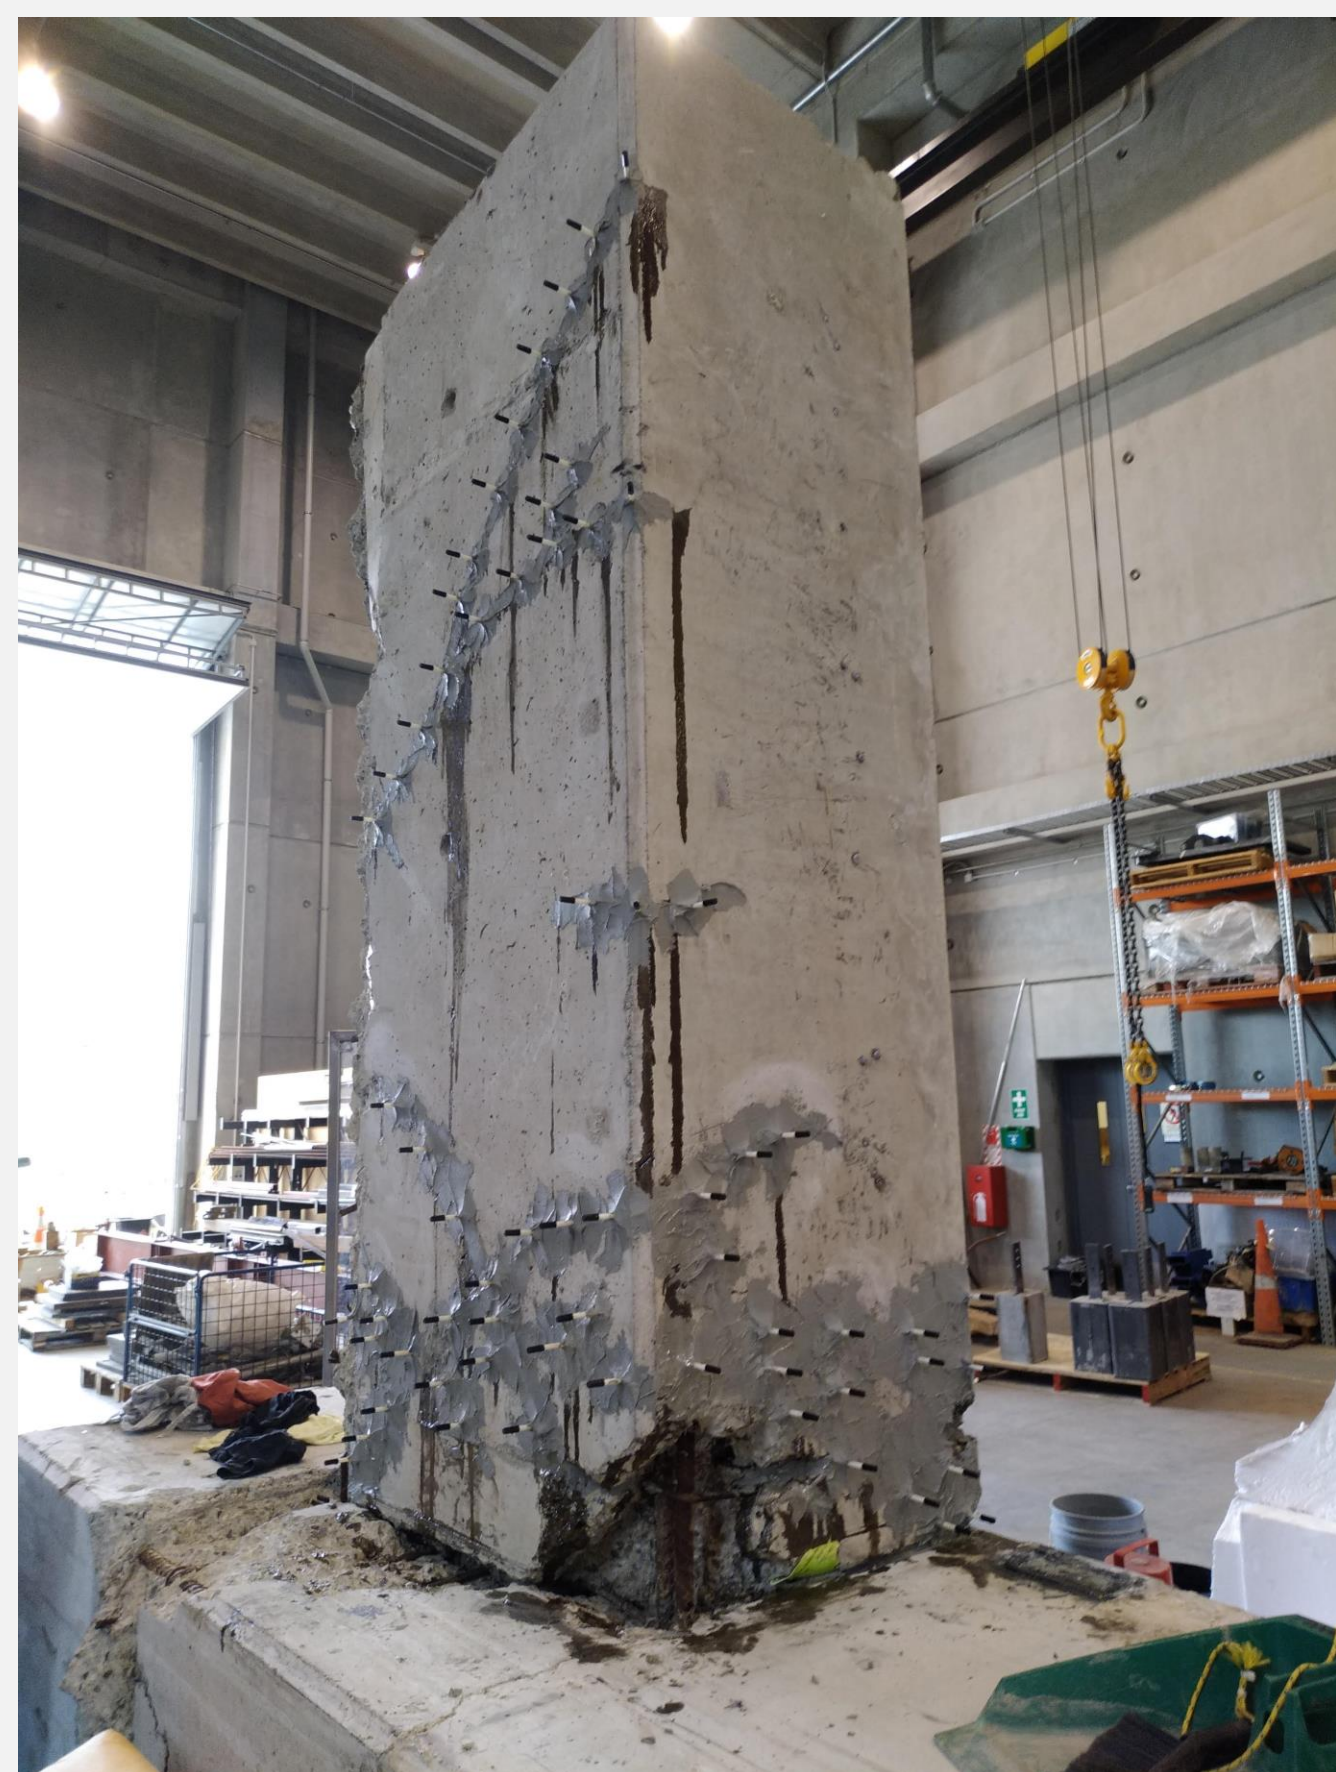
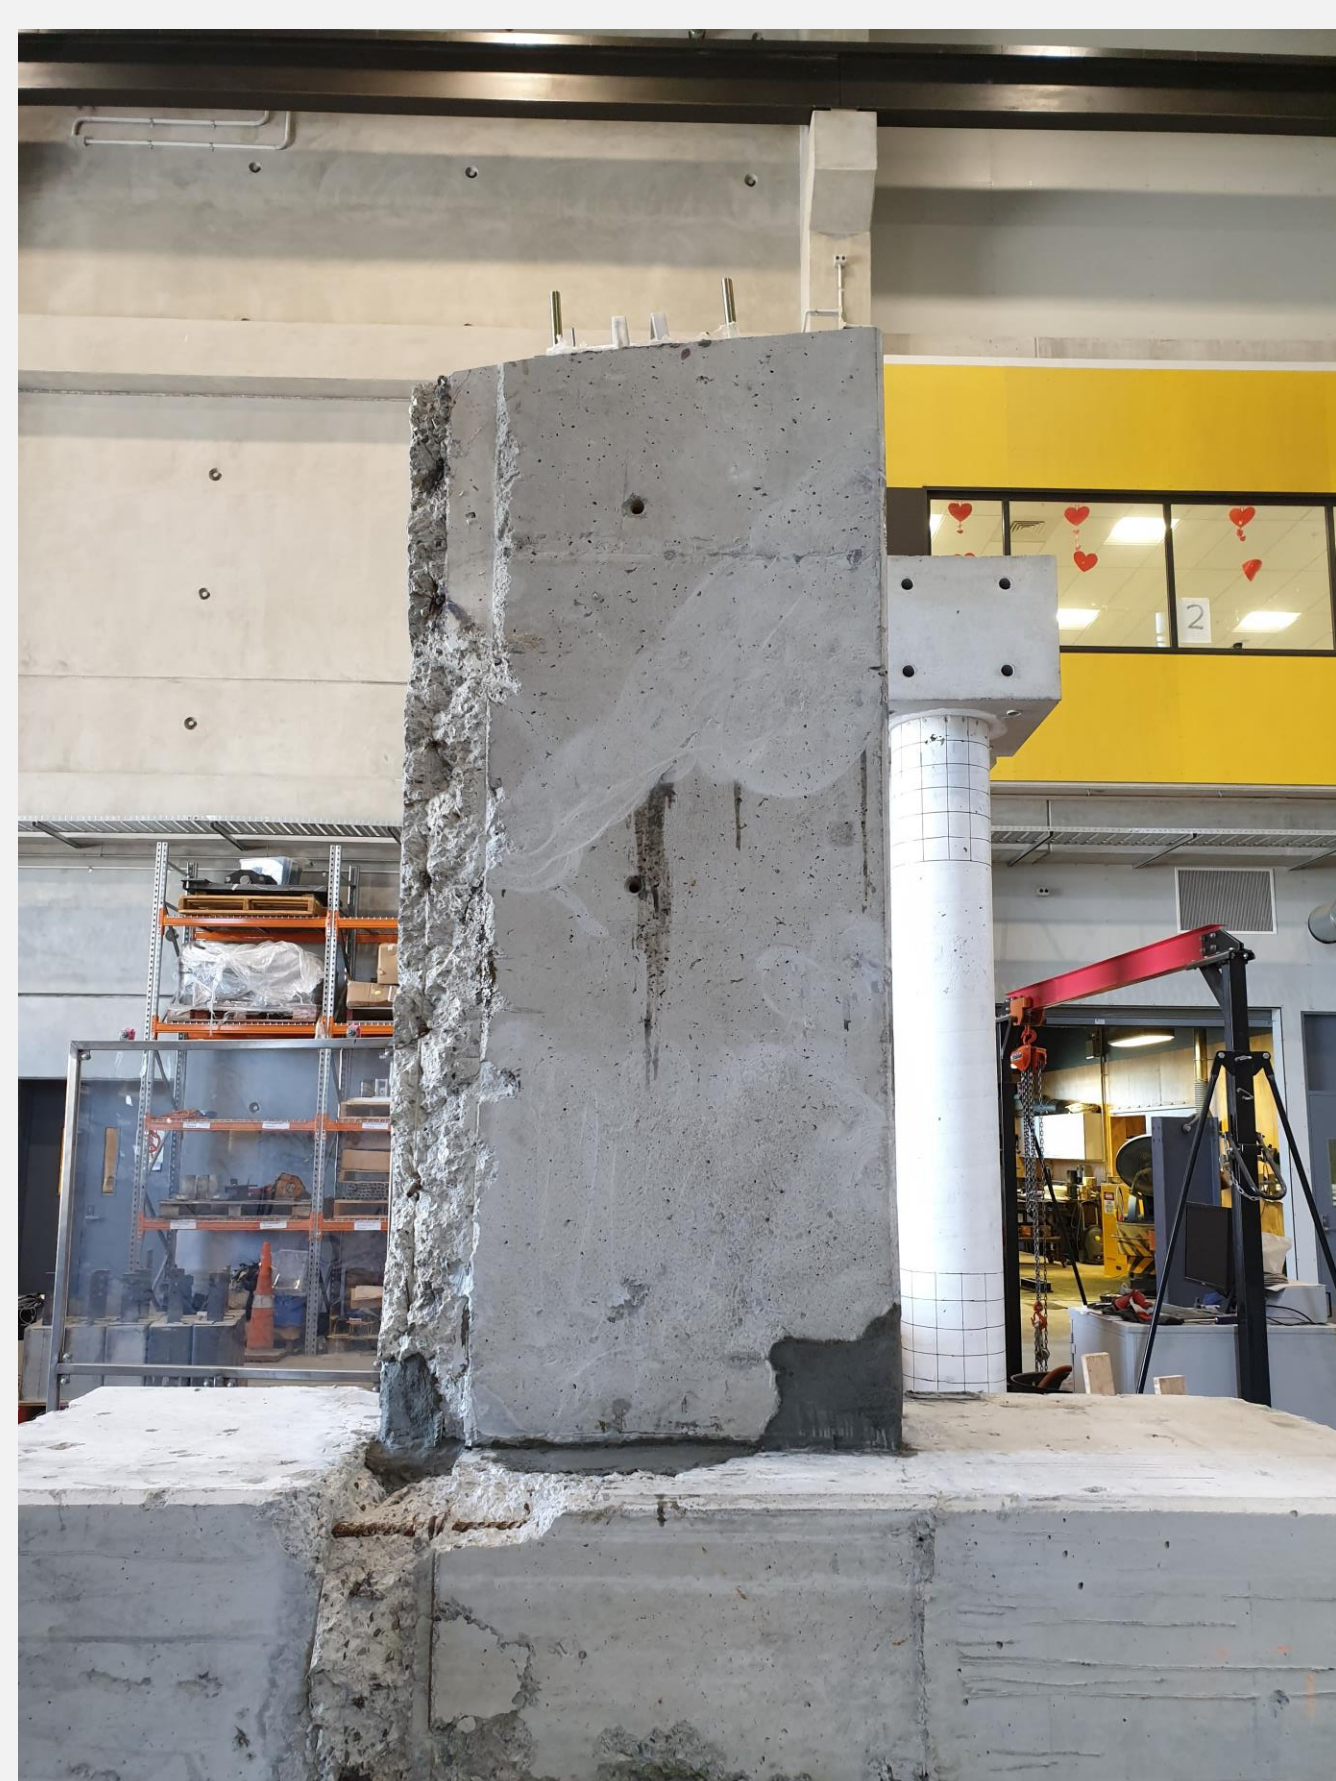
Repaired

- The repaired specimen E-R had a 26% increase in secant stiffness to yield compared to its unrepaired counterpart, E-U.
- The repaired specimen had a yield strength ~10% higher than the unrepaired specimens and ~25% higher than the predicted overstrength, likely as a result of the strain aging phenomenon of the Grade 300E reinforcement.
